Home Inspection Report

123 Old Street
Mobile, AL 36600

Prepared for: Mr & Mrs Homebuyer

Prepared by: Inspect Mobile, LLC
2 Breydon Ct
Mobile, AL 36608
Lic HI-3074

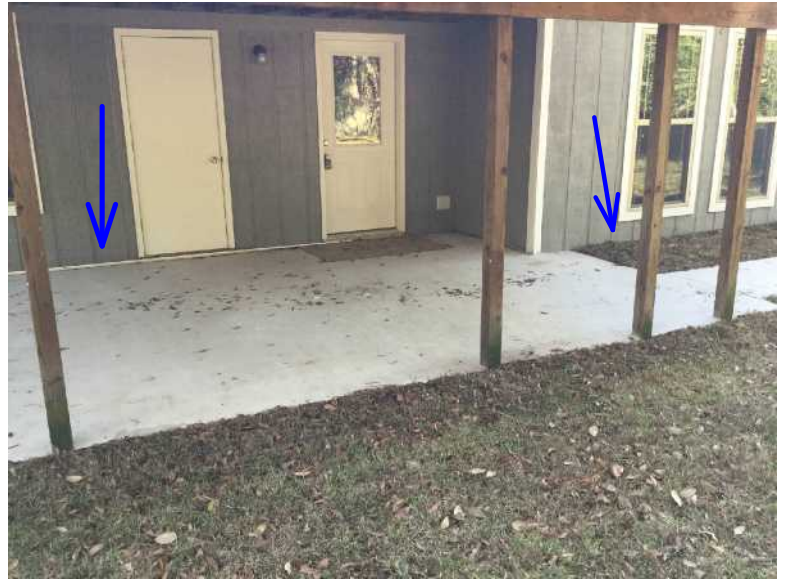
Marginal **Type:** 4'x8' cedar texture panel-- Siding in contact with soil and concrete around the home. Recommend maintain a safe clearance below the siding to prevent damage. Recommend maintain grading to slope away from the foundation.

1. **Main Exterior Surface Type:** 4'x8' cedar texture panel-- Siding in contact with soil and concrete around the home. Recommend maintain a safe clearance below the siding to prevent damage. Recommend maintain grading to slope away from the foundation.
2. **Front Door:** Metal-- Deadbolt would not latch, recommend adjust door as needed for security.
3. **Patio Door:** Metal entry door-- Hinges missing screws. Recommend installing screws to properly anchor door into the structure of the home to prevent sagging.

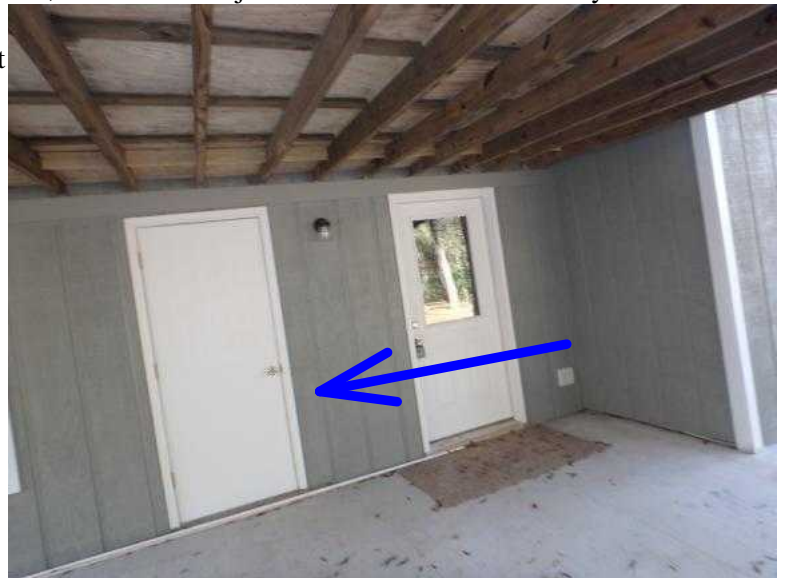
Not Inspected **Exterior Doors:** Unable to open outdoor closet door on patio or evaluate any part of that room.

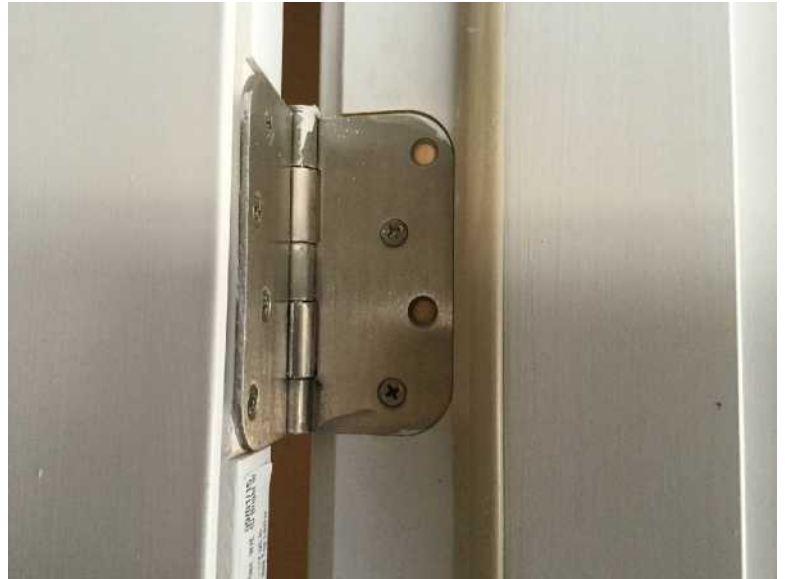
Marginal **Patio Door:** Metal entry door-- Hinges missing screws. Recommend installing screws to properly anchor door into the structure of the home to prevent sagging.

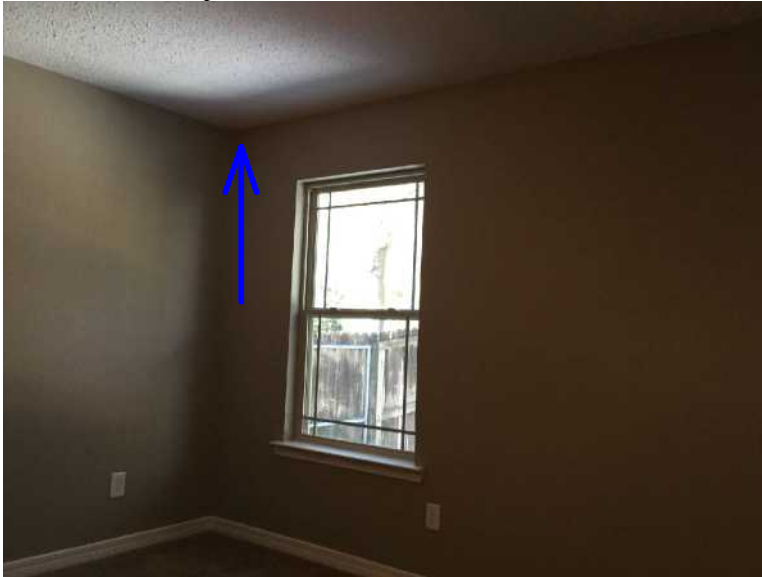
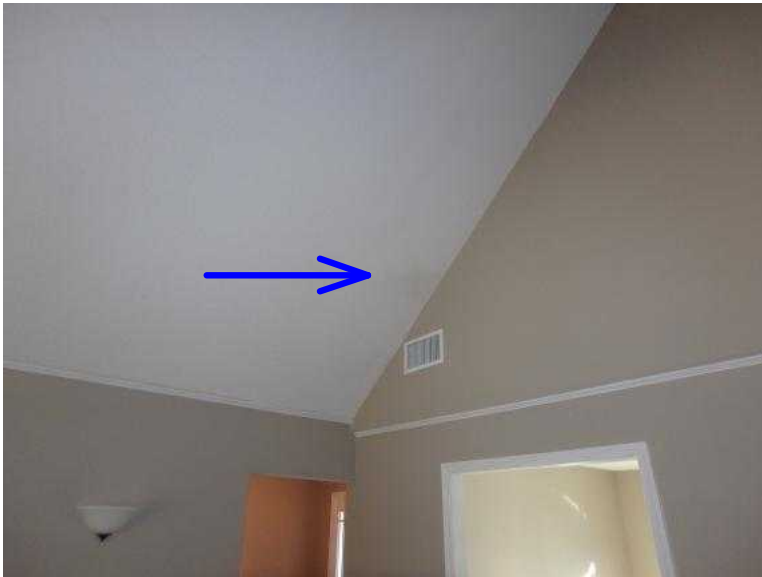
Acceptable **Ceilings:** Texture paint-- Soft spot in master bedroom to left of windows. Signs of past repairs and minor stains in various places.

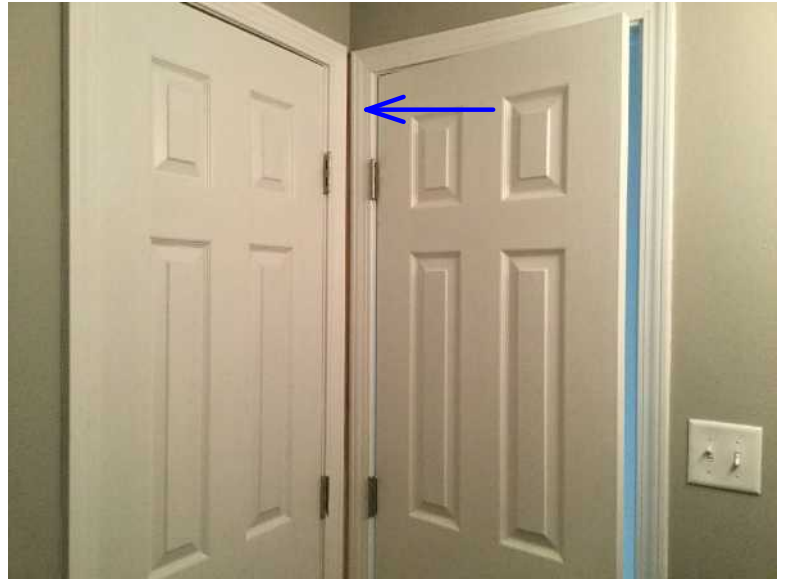
Acceptable **Walls:** Paint-- Area between doors in hall bathroom was unfinished.

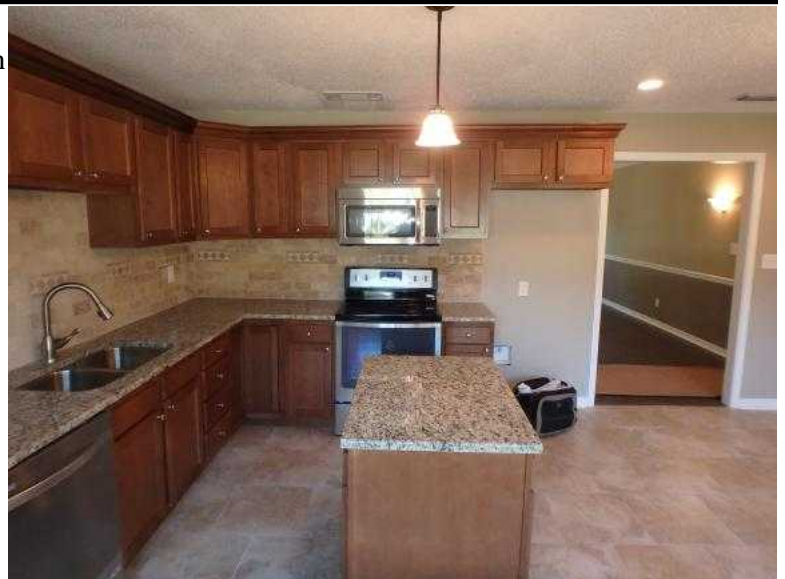
Acceptable **Kitchen Cabinets:** Wood-- Top cabinet not level. More than 1 inch height difference in the 10 foot span.

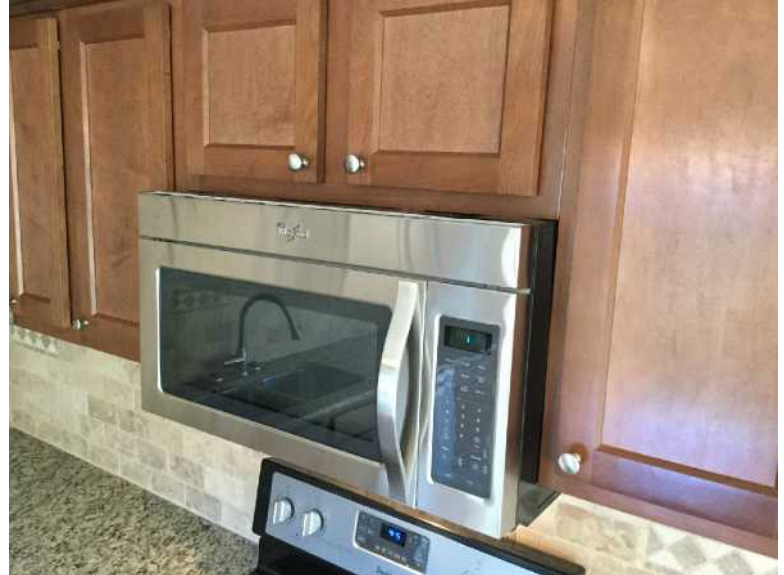
Marginal **Ventilator:** Whirlpool-- Air not properly diverted. Directing air into base of upper cabinet instead of through vent. Recommend adjust blower diverter on appliance for proper operation.

4. **Cooking Appliances:** Whirlpool-- Anti-tip bracket not installed. Recommend installing bracket to prevent oven tipping.
5. **Ventilator:** Whirlpool-- Air not properly diverted. Directing air into base of upper cabinet instead of through vent. Recommend adjust blower diverter on appliance for proper operation.

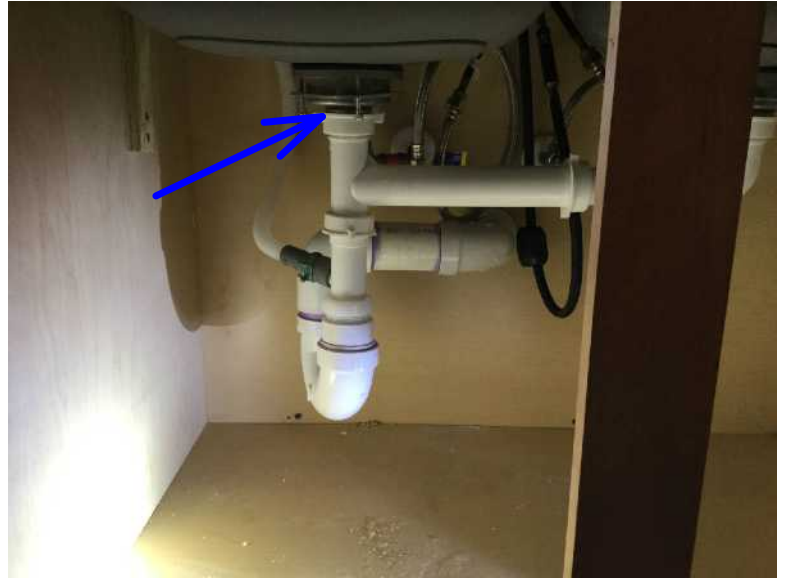
Defective **Kitchen Sink:** Stainless Steel-- Drain
leaked under left sink basin.

6. **Kitchen Sink:** Stainless Steel-- Drain leaked under left sink basin.
7. **Faucets/Traps:** Delta fixtures with a PVC trap-- A.) Master bathroom sink drain leaked. B.) Master bathroom sink overflow was blocked.

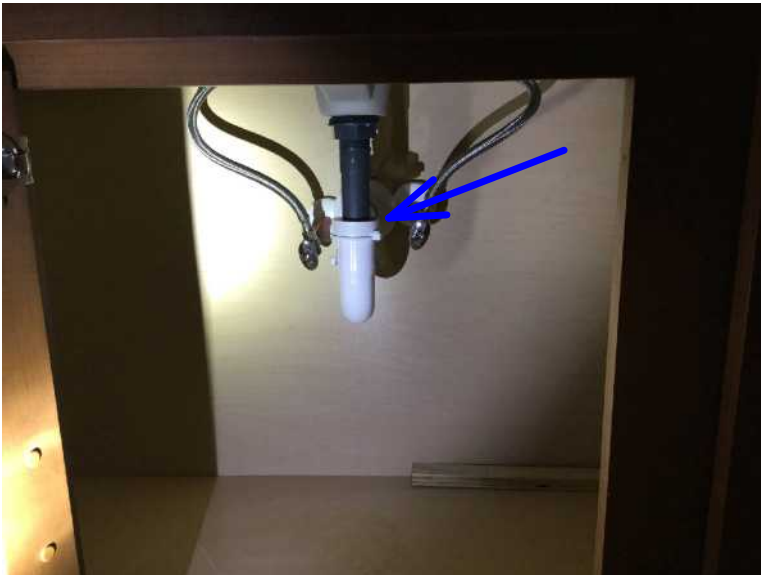
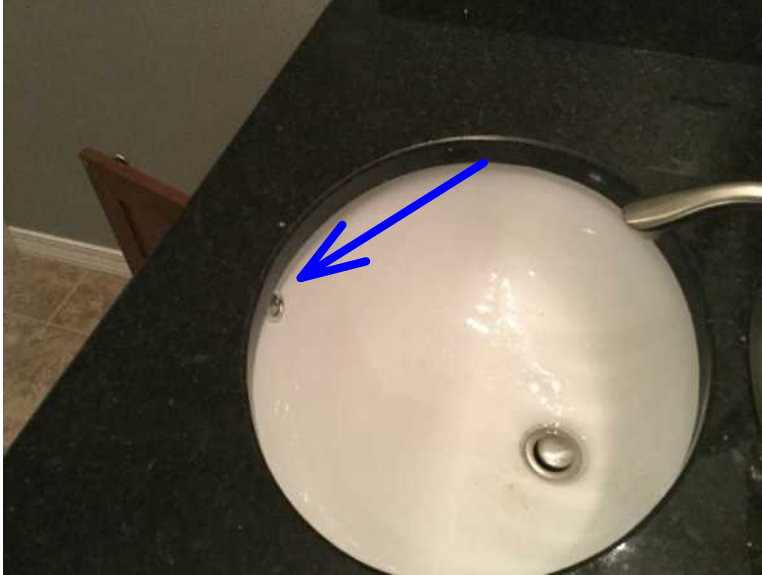
Marginal **Faucets/Traps:** Delta fixtures with a PVC trap-- A.) Master bathroom sink drain leaked. B.) Master
bathroom sink overflow was blocked.

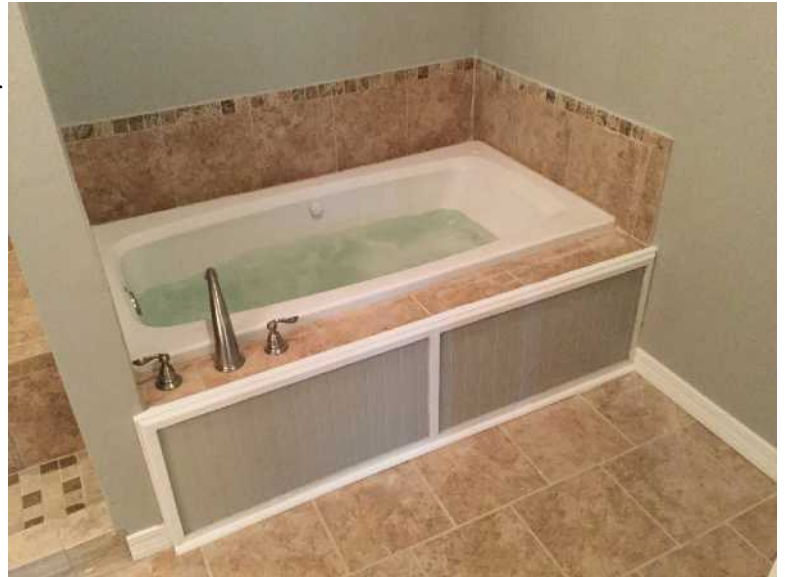
Spa Tub/Surround: Fiberglass tub and ceramic tile surround-- A.) No access to pump. B.) No evidence of GFCI protection for pump. C.) Minor cracking in tile around faucet.

8. **Spa Tub/Surround:** Fiberglass tub and ceramic tile surround-- A.) No access to pump. B.) No evidence of GFCI protection for pump. C.) Minor cracking in tile around faucet.

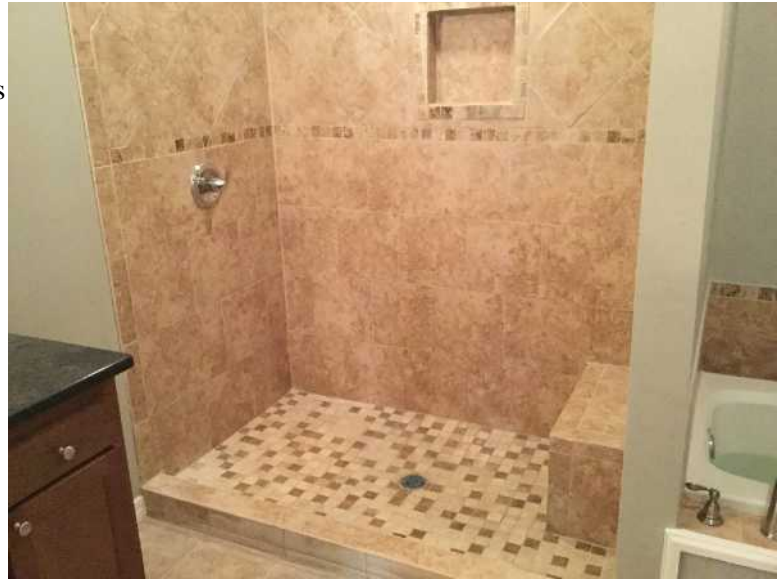
Marginal **Shower/Surround:** Tile-- Poor craftsmanship with multiple cracked tiles, grout residue, bench will be vulnerable to leaks

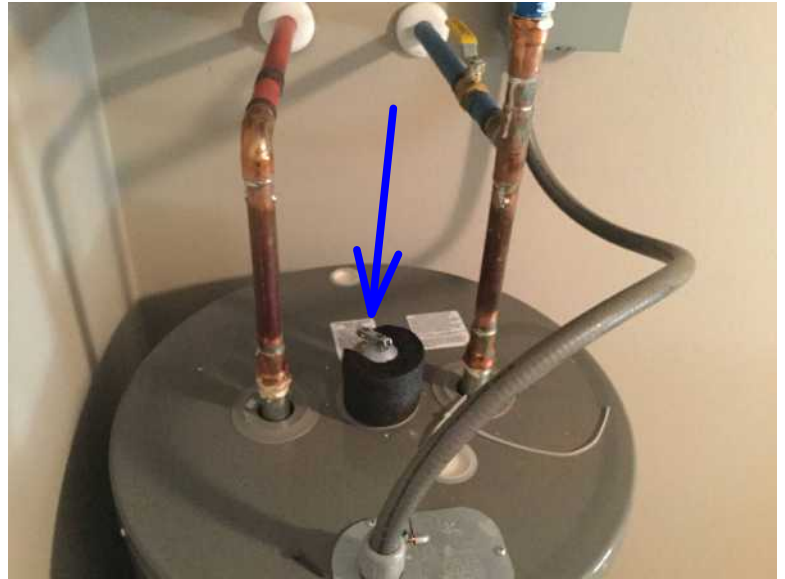
TPRV and Drain Tube: Missing drain tube at TPR valve. Signs of unpermitted installation. Recommend further evaluation and repairs by a qualified plumber.

9. **Shower/Surround:** Tile-- Poor craftsmanship with multiple cracked tiles, grout residue, bench will be vulnerable to leaks
10. **Laundry Room Water Heater TPRV and Drain Tube:** Missing drain tube at TPR valve. Signs of unpermitted installation. Recommend further evaluation and repairs by a qualified plumber.

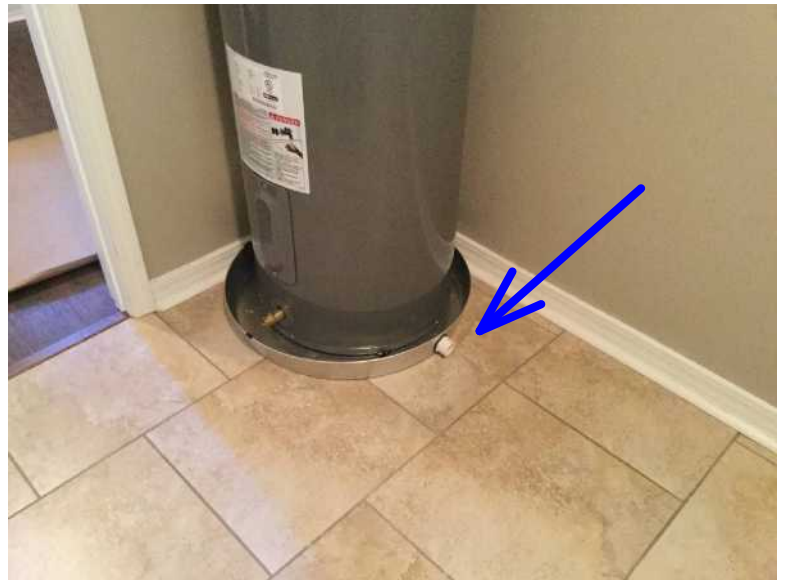
Expansion Tank: Vertical Mount
Drain Pan: Present-- Recommend a watertight drain pan under any water heater located where a leak can damage house finishings. A drain line should be connected and drain to an approved location.

11. **Laundry Room Water Heater Drain Pan:** Present-- Recommend a watertight drain pan under any water heater located where a leak can damage house finishings. A drain line should be connected and drain to an approved location.

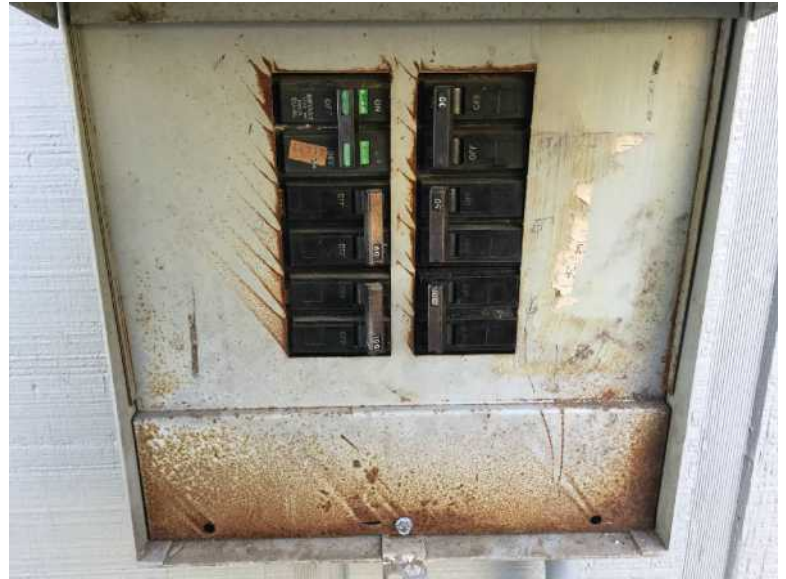
Acceptable **Manufacturer:** General Electric--
Breakers are not identified, recommend
labeling breakers.

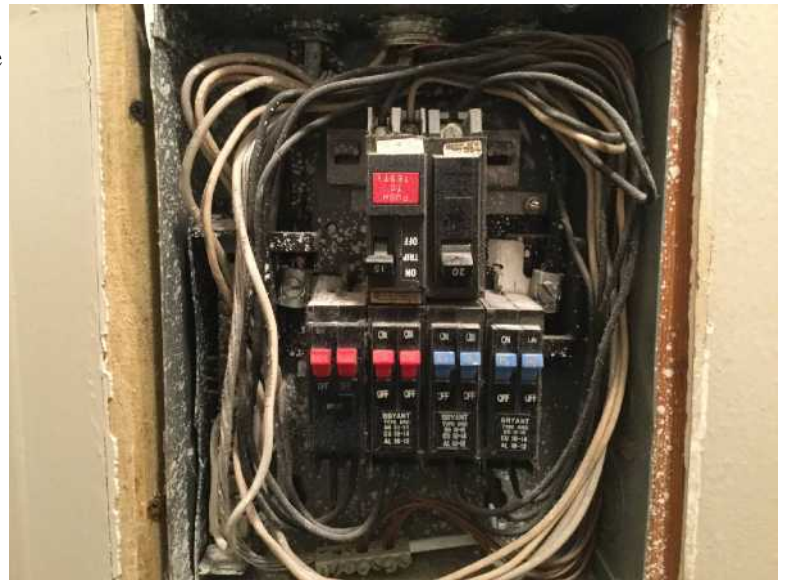
Marginal **Breakers:** Copper-- Paint over spray inside the panel and on the main bus bars. The paint impairs the transfer of electricity and can cause overheating and fire. Recommend the panel be further evaluated by an electrical contractor for safe operation.

12. **Closet Electric Panel Breakers:** Copper-- Paint over spray inside the panel and on the main bus bars. The paint impairs the transfer of electricity and can cause overheating and fire. Recommend the panel be further evaluated by an electrical contractor for safe operation.

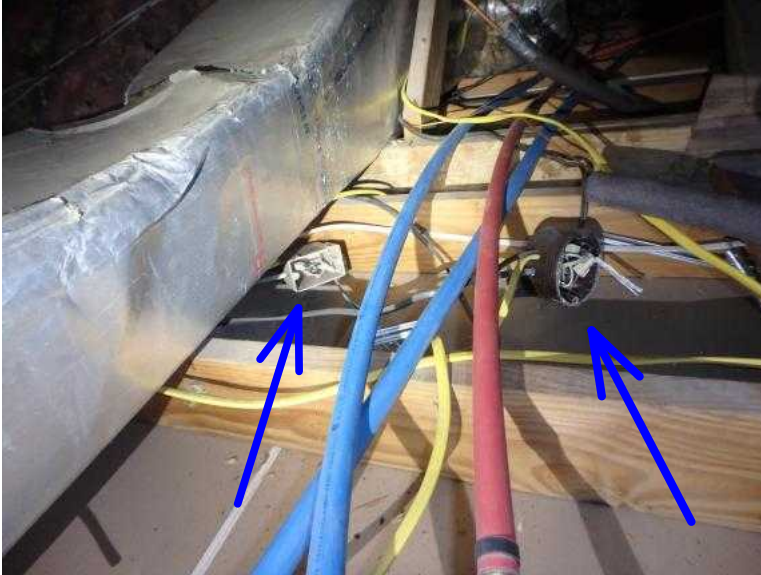
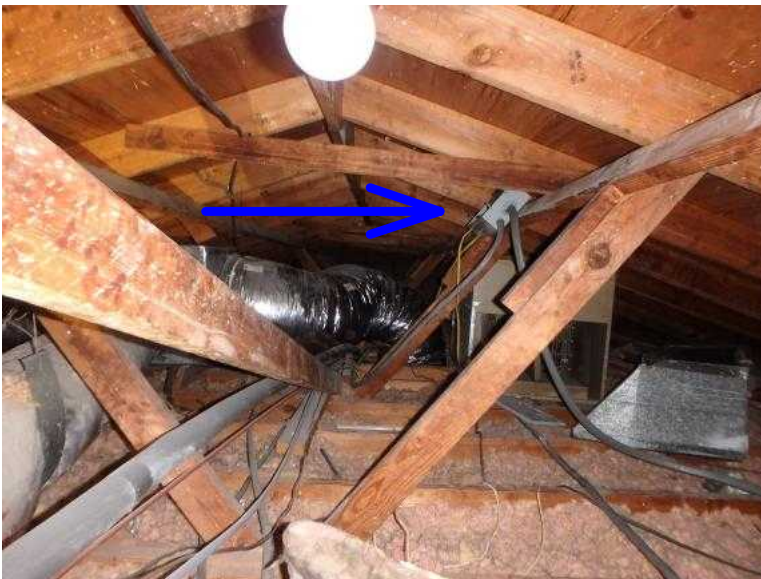
Defective **120 VAC Branch Circuits:** Copper-- 2 open junction boxes in the attic above the master bathroom need cover plates installed. Cover missing from box above laundry room.

13. **120 VAC Branch Circuits:** Copper-- 2 open junction boxes in the attic above the master bathroom need cover plates installed. Cover missing from box above laundry room.

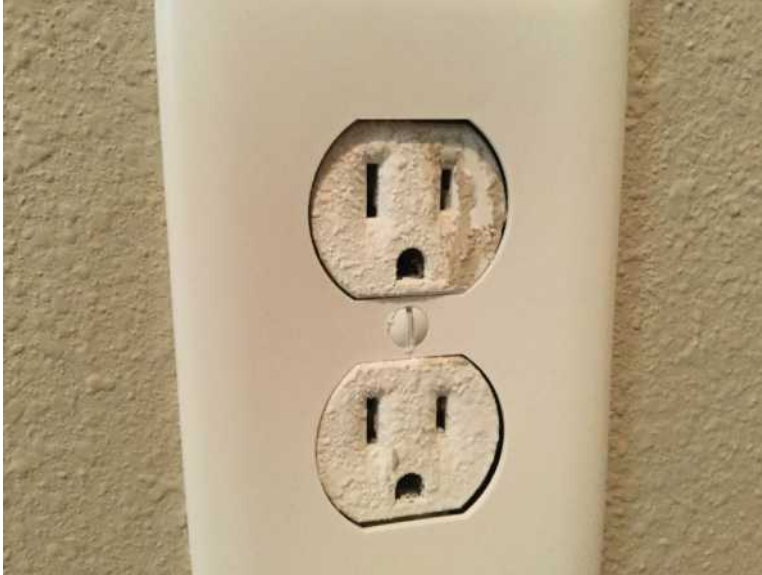
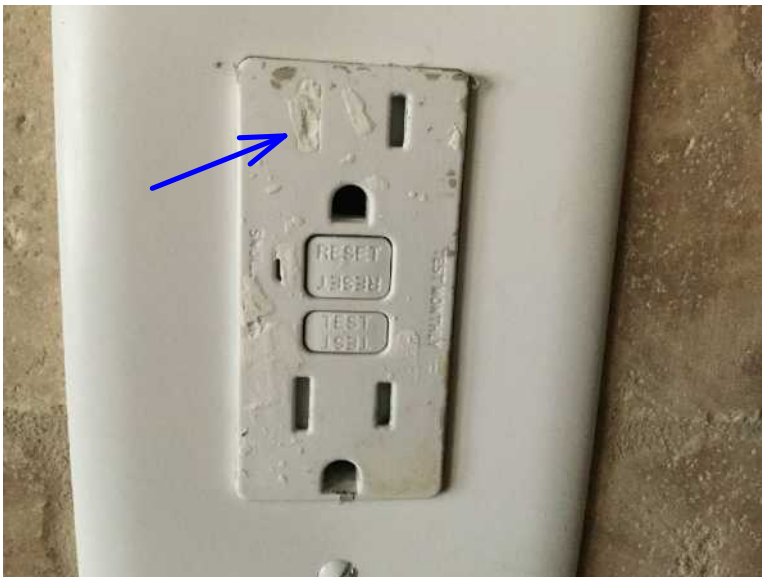
Marginal **120 VAC Outlets:** Grounded-- Multiple outlets were found to have the face painted. This is a fire hazard as paint can get pushed into the socket. Recommend replace painted receptacles.

14. **120 VAC Outlets:** Grounded-- Multiple outlets were found to have the face painted. This is a fire hazard as paint can get pushed into the socket. Recommend replace painted receptacles.

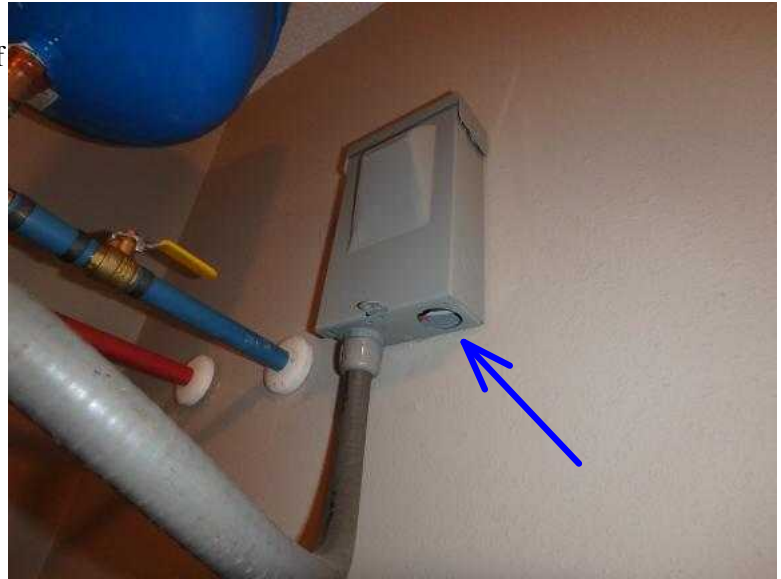
Marginal **240 VAC Outlets:** 3-pole 3-wire grounded-- Open knock out hole in bottom of water heater power shut off box. Recommend seal hole with an approved cover.

15. **240 VAC Outlets:** 3-pole 3-wire grounded-- Open knock out hole in bottom of water heater power shut off box. Recommend seal hole with an approved cover.

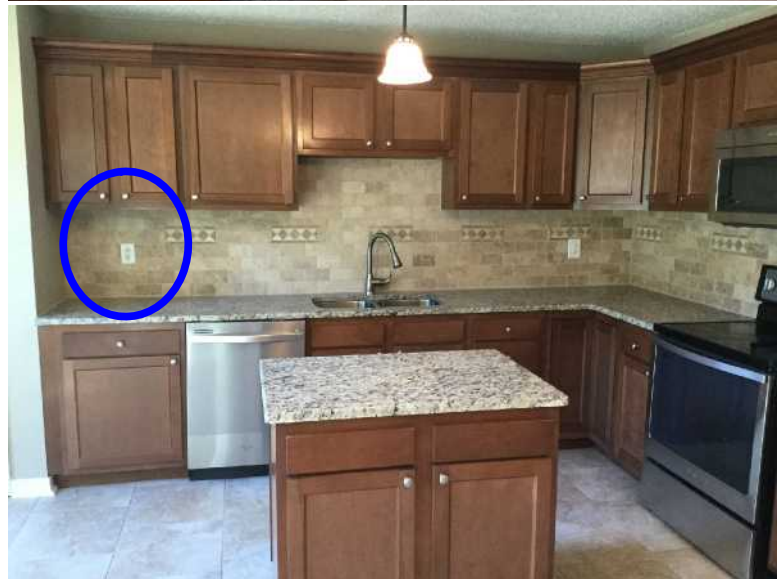
Defective **GFCI:** Kitchen and bathrooms-- Outlet to left of kitchen sink was not protected by GFCI.

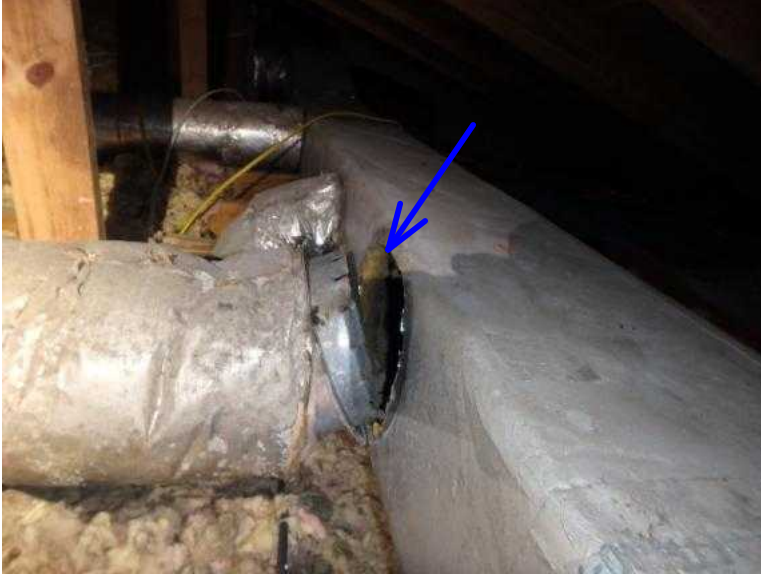
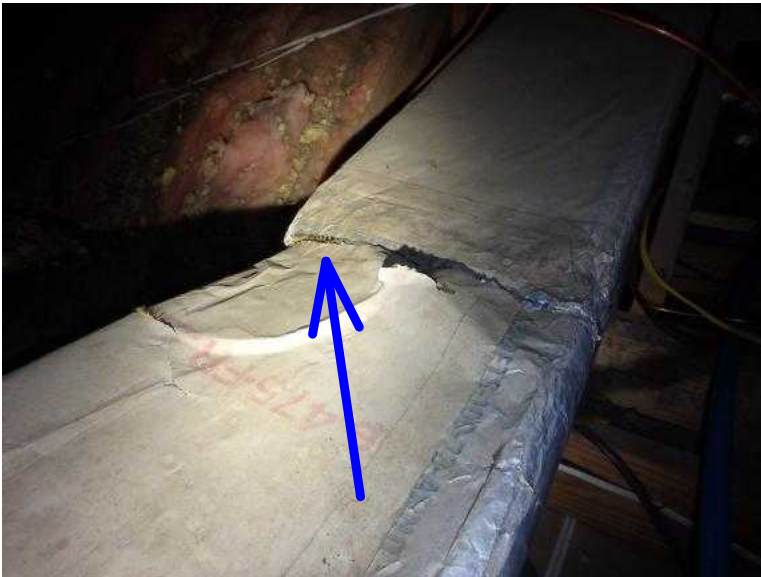
Exposed Ductwork: Ductboard and metal-- Loose duct above master bedroom closet. Damaged trunk line above kitchen/master bedroom wall where air can escape. Recommend seal any air leaks in ductwork.

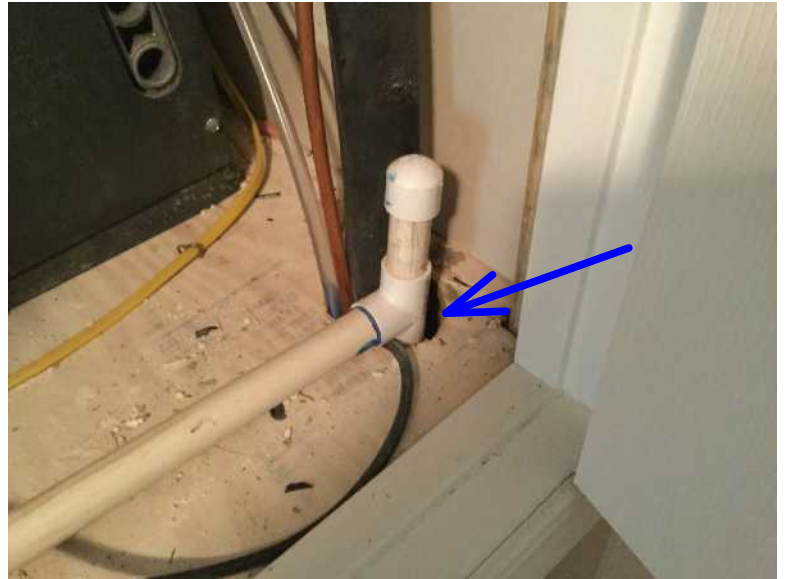
Air Return: Under Air Handler--
Recommend seal gaps that could allow air into the unit without first passing through the filter.

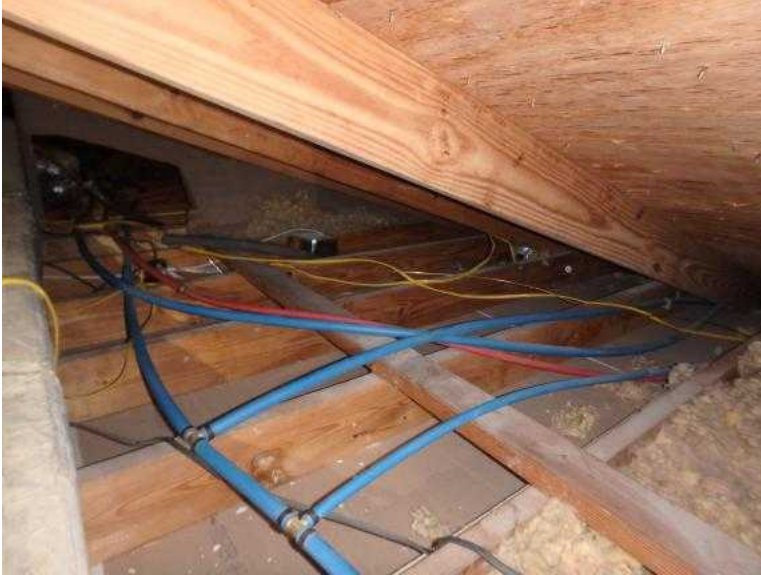
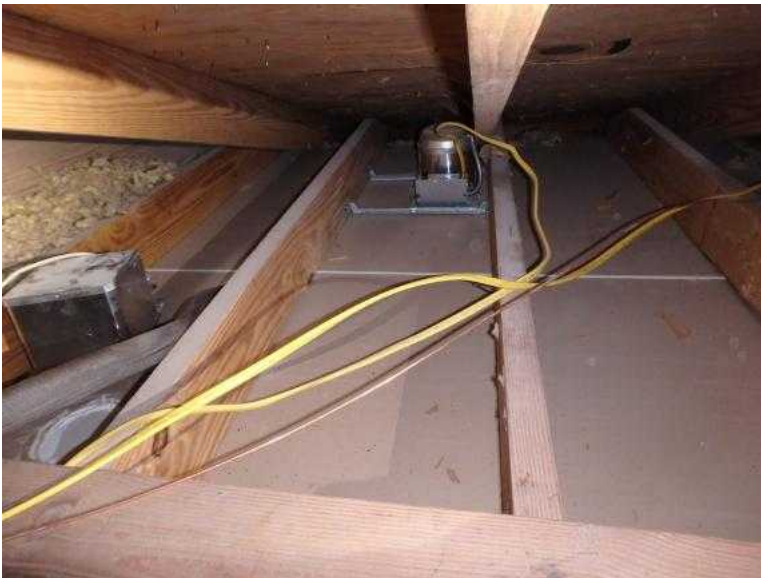
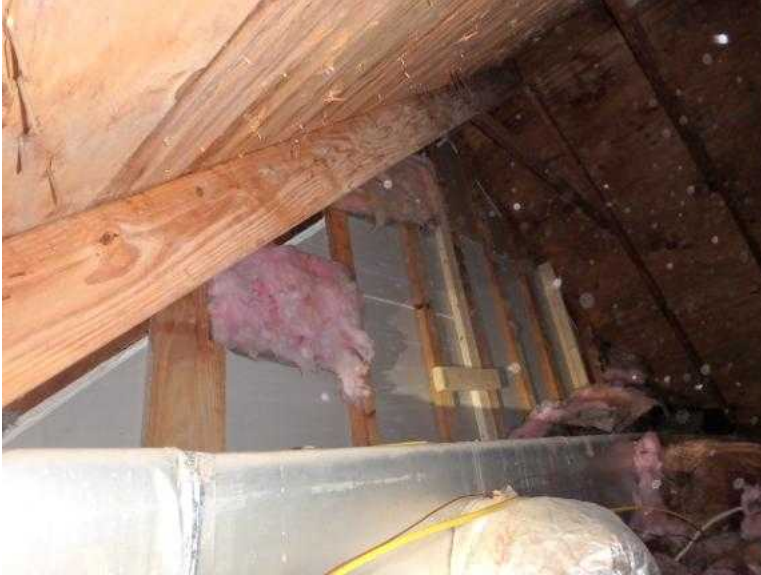
Insulation: Fiberglass-- Insufficient insulation present, Recommend additional insulation be installed

- 21. Attic Insulation:** Fiberglass-- Insufficient insulation present, Recommend additional insulation be installed

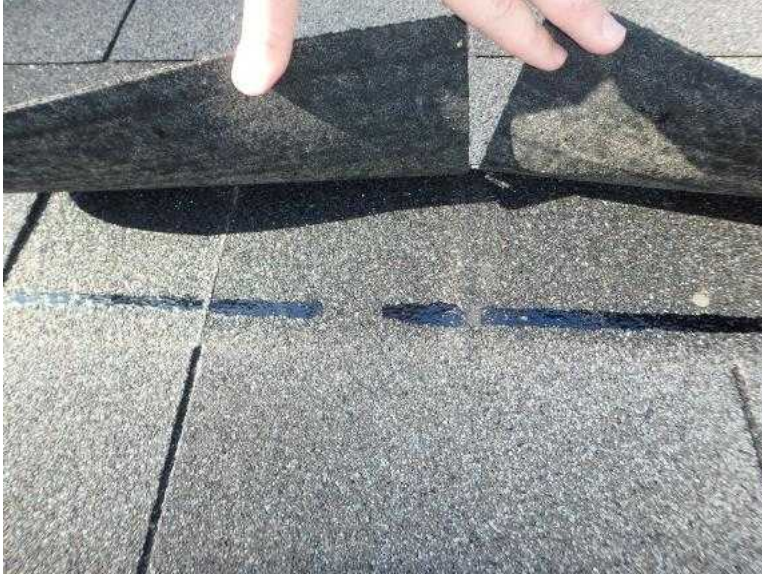
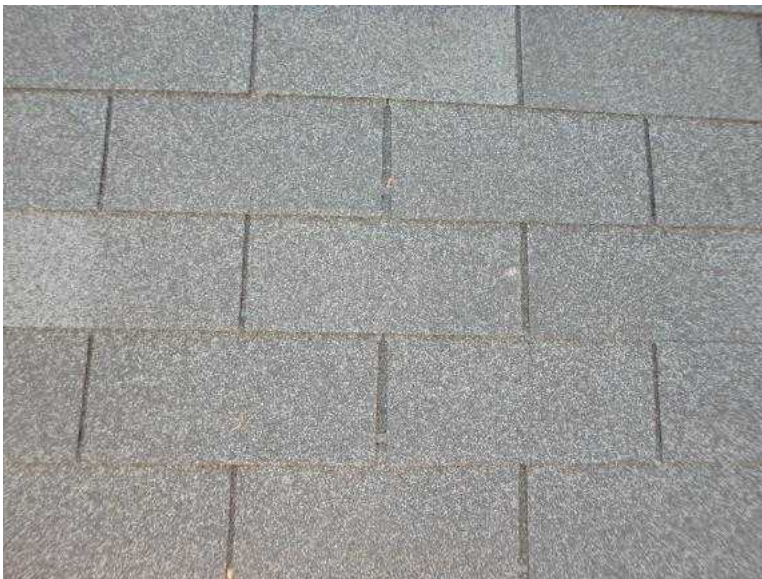
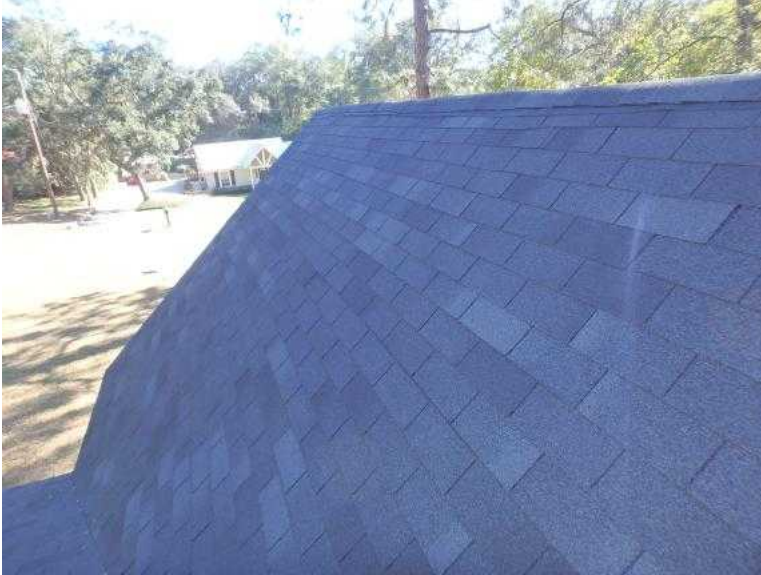
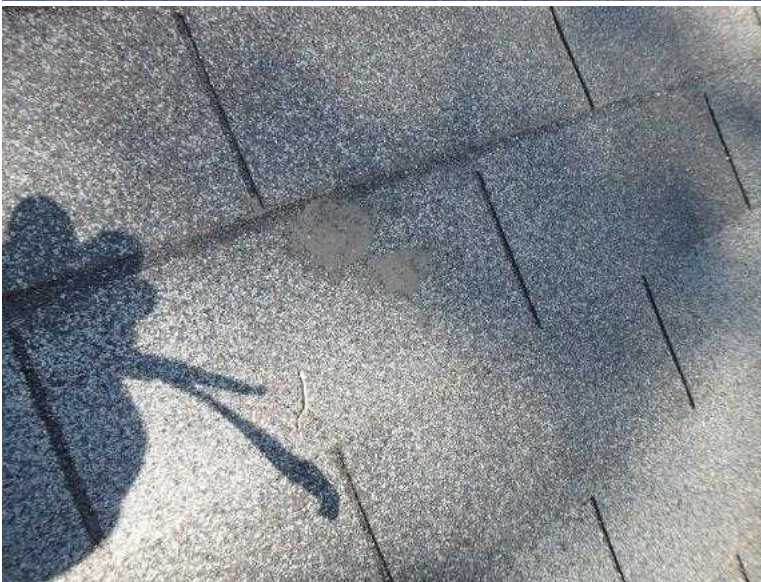
Material: 3-Tab Shingle-- Improper nailing pattern, signs of shingles sliding out of place with tearing around nails, shingles not sealed. Recommend further evaluation and repairs by a qualified roofing contractor.

- 22. Main Roof Surface Material:** 3-Tab Shingle-- Improper nailing patter, signs of shingles sliding out of place with tearing around nails, shingles not sealed. Recommend further evaluation and repairs by a qualified roofing contractor.
- 23. Drip Edge:** No drip edge flashing around roof of back patio.

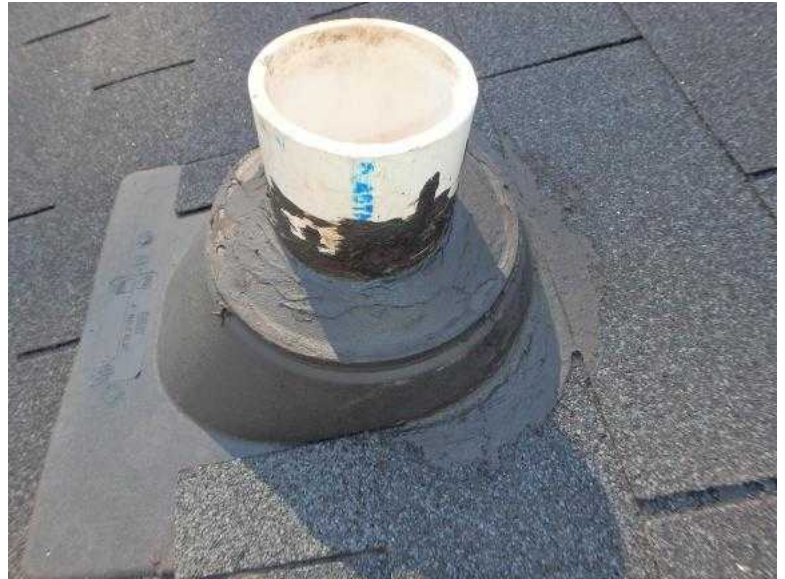
Plumbing Vents: Neoprene boot-- Roof sealant used around vent pipes is an indication of unprofessional repairs.

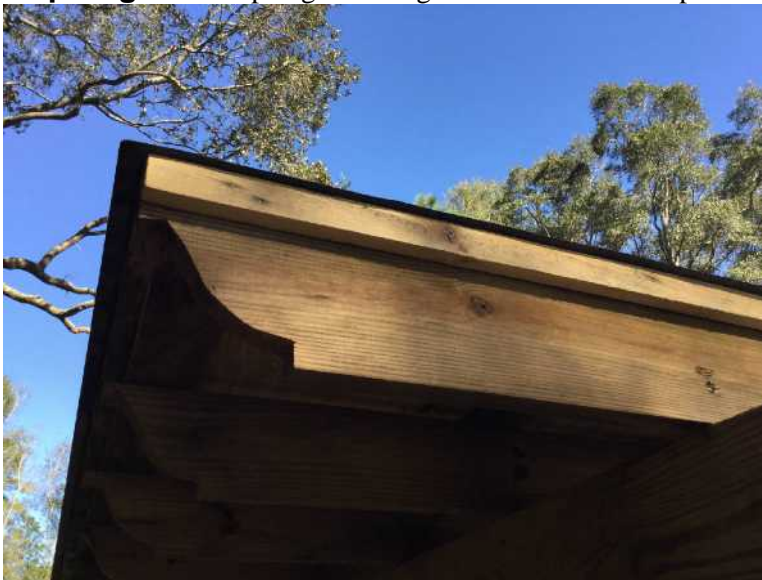
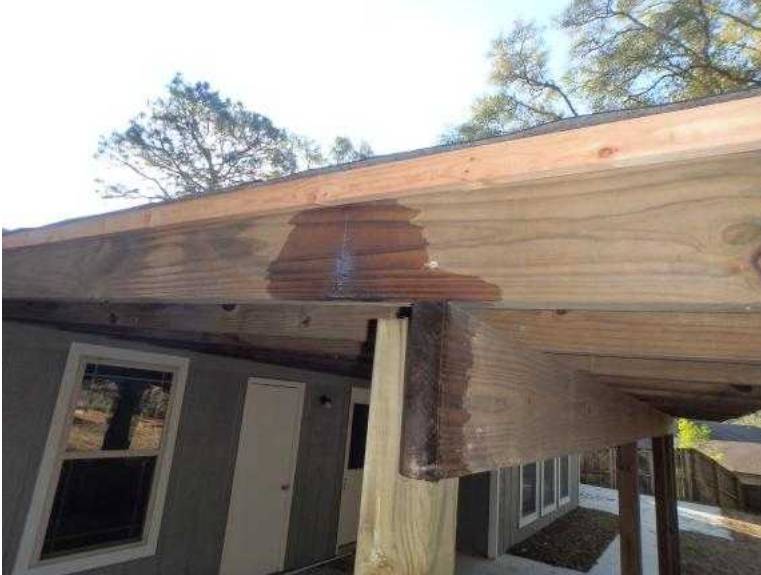
Drip Edge: No drip edge flashing around roof of back patio.
