Home Inspection Report

123 Old Street
Mobile, AL 36600

Prepared for: Mr & Mrs Homebuyer

Prepared by: Inspect Mobile, LLC
2 Breydon Ct
Mobile, AL 36608
Lic HI-3074

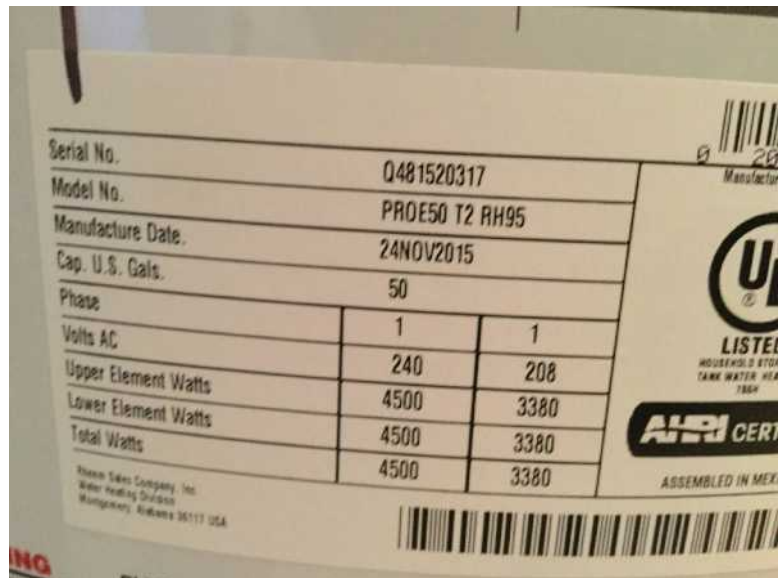
Acceptable **Operation:** Functional at time of inspection

Manufacturer: Rheem

Type: Electric **Capacity:** 50 Gal.

Approximate Age: New **Area Served:** Whole building

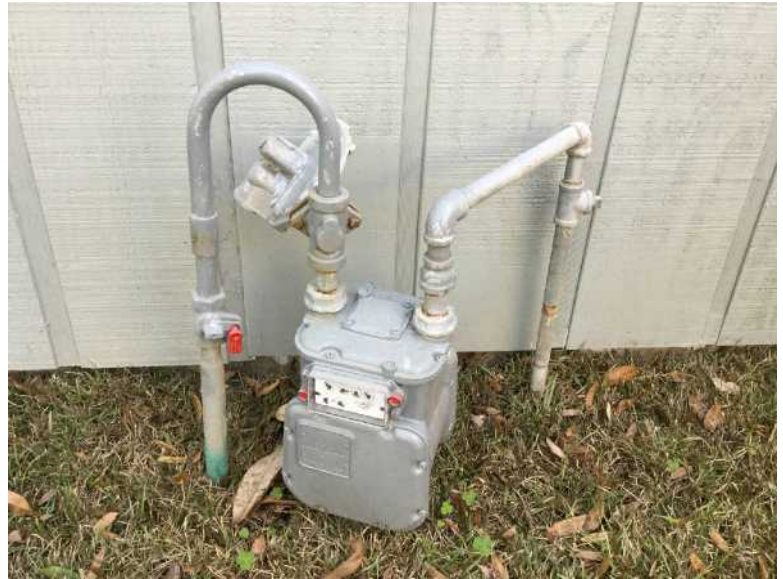
Acceptable **Gas Meter:** Exterior surface mount at side of home-- No gas using appliances in home.

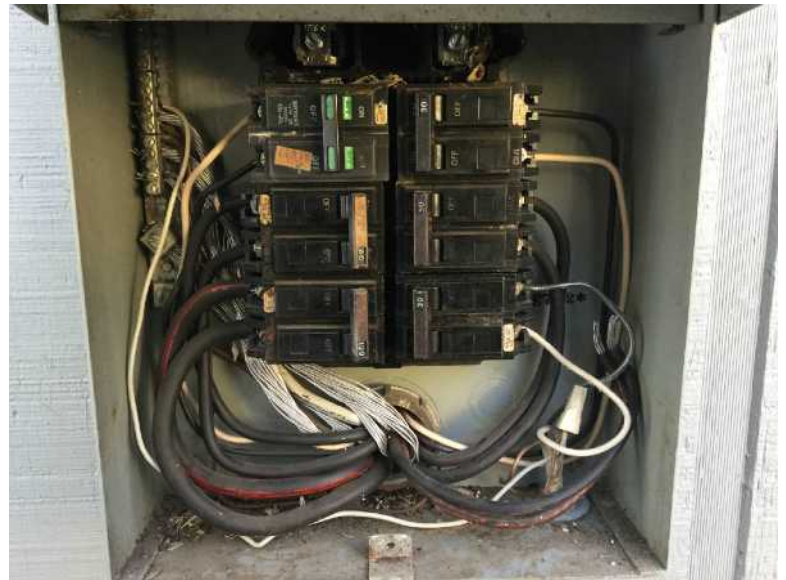
Acceptable **Breakers:** Copper and Aluminum

Is the panel bonded? Yes

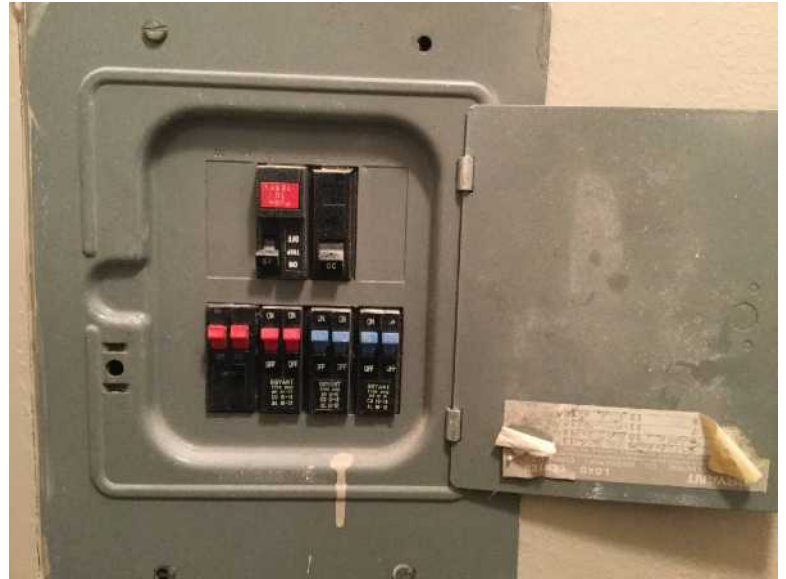
Acceptable **Manufacturer:** Bryant

Maximum Capacity: 100 Amps

Marginal **Breakers:** Copper-- Paint over spray inside the panel and on the main bus bars. The paint impairs the transfer of electricity and can cause overheating and fire. Recommend the panel be further evaluated by an electrical contractor for safe operation.

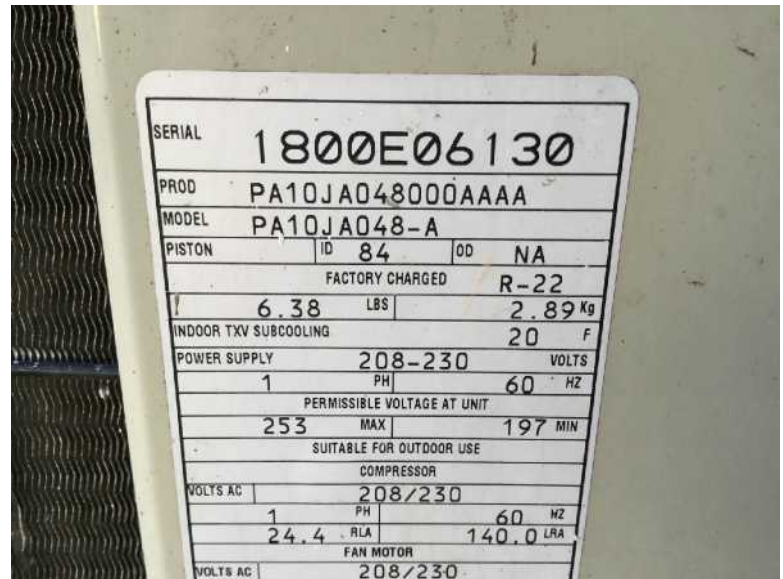
Acceptable **Exterior Unit:** Pad mounted

Manufacturer: Payne

Area Served: Whole building **Approximate Age:** 15 years

Type: Central A/C **Capacity:** 4 Ton

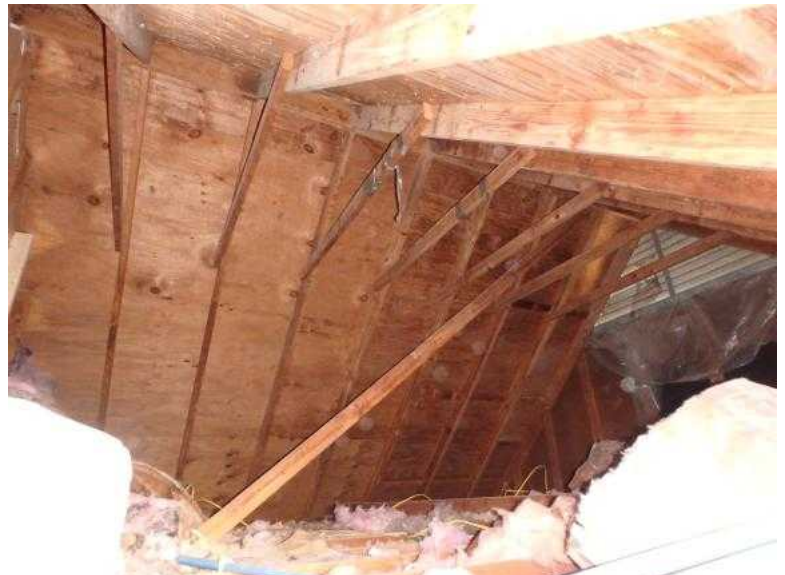
Acceptable **Roof Framing:** 2x6 Rafter
